## NASA SAFETY CENTER SYSTEM FAILURE CASE STUDY

December 2017 Vol. 10 Issue 2

### VALUKAS REPORT REVEALS SOCIAL AND TECHNICAL ISSUES BEHIND FAULTY GM IGNITION SWITCH

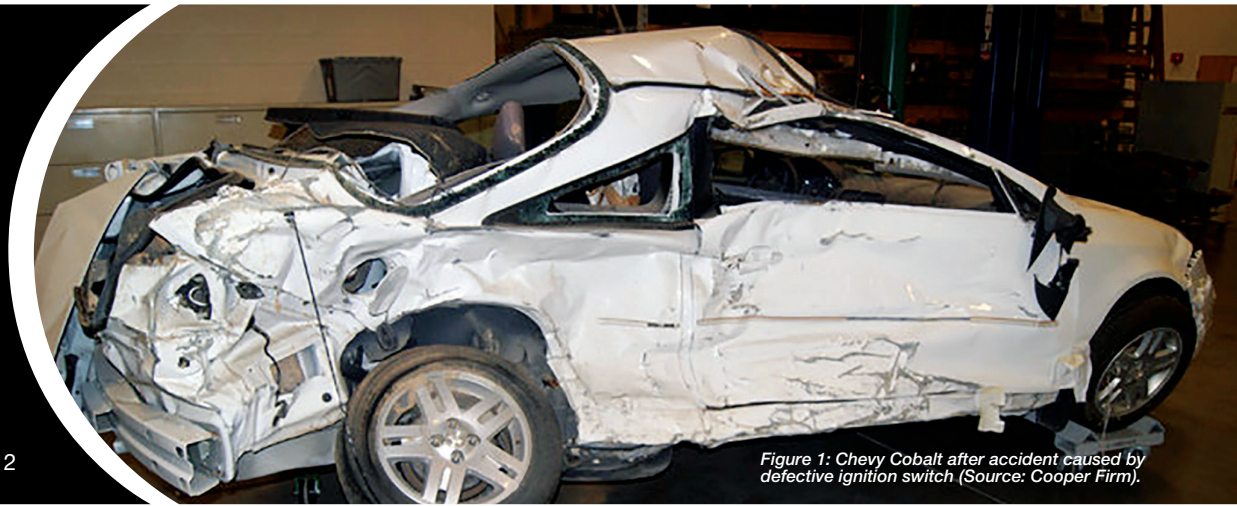
Figure 1: Chevy Cobalt after accident caused by defective ignition switch (Source: Cooper Firm).

The ignition switch did not meet the mechanical specifications for torque and required less force to turn the key than its designers originally ordered. If the driver's knee hit the key fob, the car would often turn off, causing stalling at highway speeds and disabling the airbags.

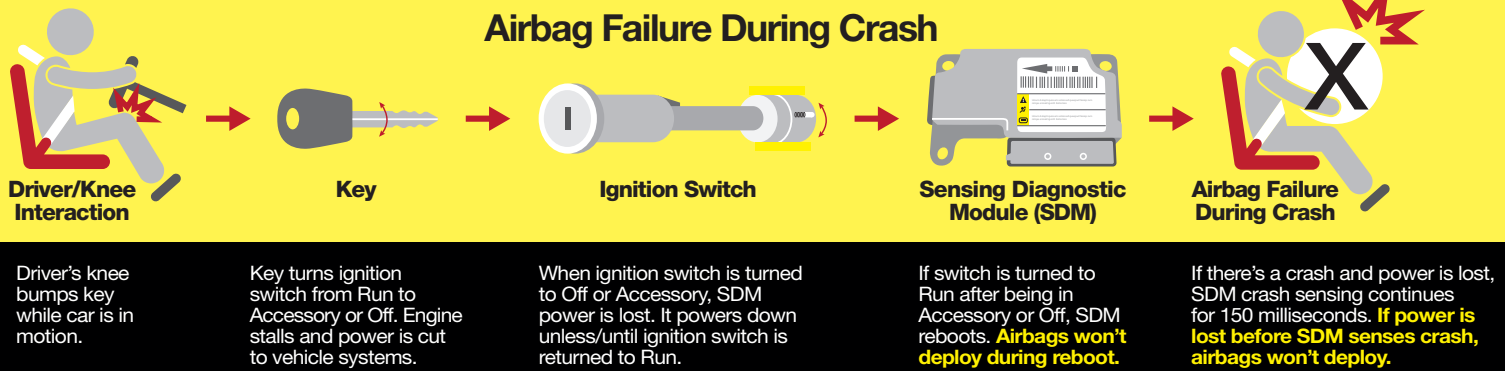
When the Cobalt's ignition switch is turned to Off or Accessory, SDM power is lost and the module powers down unless or until the switch is returned to Run. This safety feature helps to minimize unintended airbag deployments when the driver is not sitting in a proper, restrained position. However, when the switch is turned to Run after being in Accessory or Off (e.g., when the driver's knee bumps the key fob or keychain), the SDM "reboots," turning itself Off and then On. During the reboot process, which takes a few seconds, the vehicle's airbags will not deploy. In the event of a crash and vehicle power loss, the SDM crash sensing will continue for about 150 milliseconds after the power loss. The Valukas report concluded that if power was lost before the SDM started to sense the crash, the airbags wouldn't deploy.

Figure 4: Chain of events leading to airbag failure during a car crash (Source: NASA Safety Center).
